JUNE 2016 TO SEPTEMBER 2016

Parkwood LTP Fabrication Works Case Study

The Parkwood Leachate Treatment Plant is operated by Viridor Waste Management (Viridor). Located at the Parkwood Landfill Site in Sheffield, it is designed to treat leachate generated from the Parkwood landfill Site before being discharged to sewer.

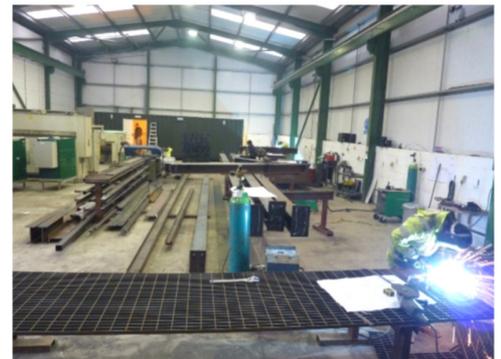
All fabrication was undertaken at the Phoenix Fabrication Unit in Cornwall.

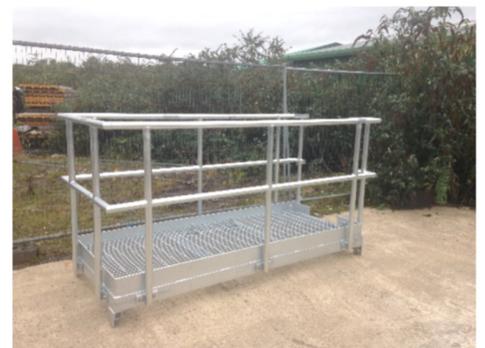
Galvanizing

All fabricated steel was galvanized locally, stored and then transported to site for installation.
